7.0 Green River, Utah, Disposal Site

7.1 Compliance Summary

The Green River, Utah, Disposal Site, inspected on March 8, 2007, was in excellent condition. Unnecessary groundwater monitoring wells were decommissioned and telemetry systems were installed in several wells during 2007. Groundwater monitoring continued for the purpose of evaluating cell performance; no constituents of concern exceed their respective proposed alternate concentration limits. No cause for a follow-up or contingency inspection was identified.

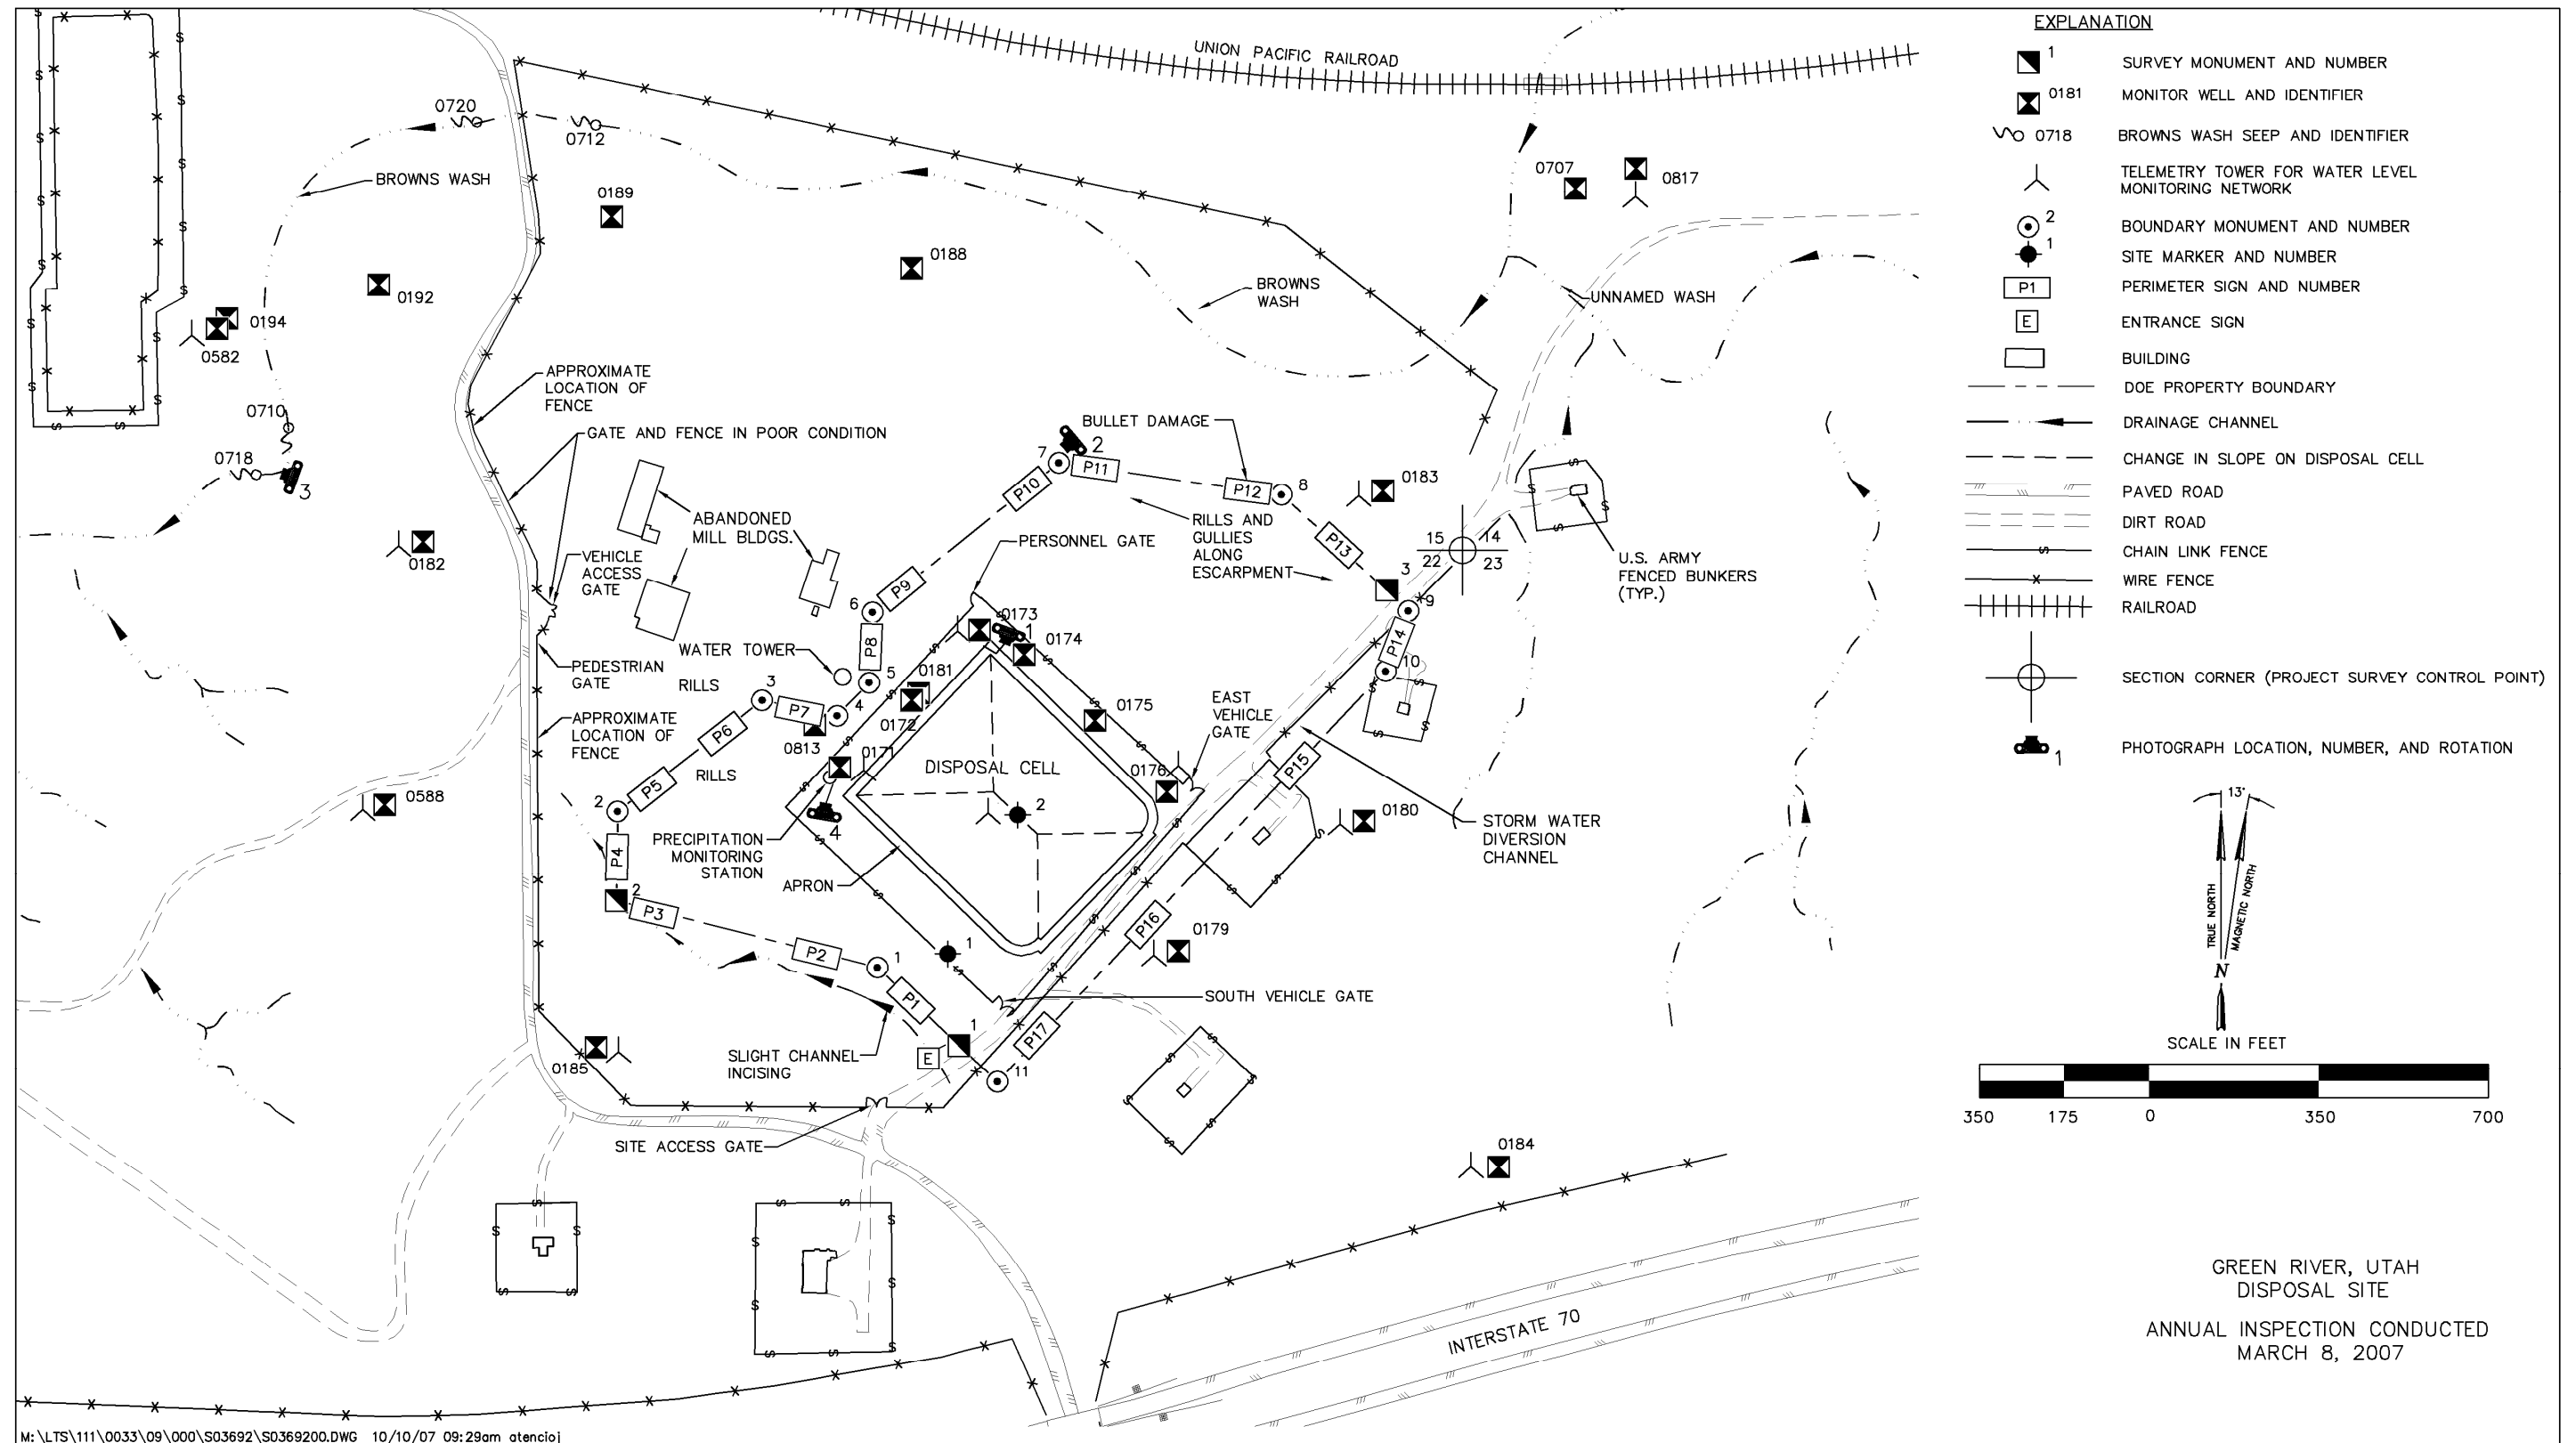
Figure 7-1. 2007 Annual Compliance Drawing for the Green River, Utah, Disposal Site

One entrance sign and 17 perimeter signs are positioned on posts set along the unfenced site boundary. Perimeter sign P12 has a bullet dent but is legible; the remaining signs were in excellent condition.

Disposal Cell and Adjacent Area Inside the Security Fence—The 6-acre disposal cell was completed in 1989. The slopes of the disposal cell cover are armored with basalt rock. The cell cover was in excellent condition. The riprap-filled apron trench along the base of the disposal cell on all sides was in excellent condition (PL-1).

Site Perimeter Between the Security Fence and the Site Boundary—Rills and gullies are present on the west side of the property but do not pose a threat to the integrity of the cell and currently are not impacting any site surveillance features. Rills and gullies are also present along the escarpment northeast of the disposal cell in the area between boundary monument BM-7 and survey monument SM-3 (PL-2). Maximum gully depth in this area is approximately 3 feet. The rill and gully erosion poses no threat to the integrity of the disposal cell but could eventually damage perimeter signs and boundary monuments.

A barbed-wire stock fence on the surrounding state-owned property is in poor condition, and an access gate through the fence to abandoned mill buildings northwest of DOE property was heavily damaged and open. Tracks indicate that vehicles enter the gate and cross DOE property to access areas northeast of the site. However, there was no evidence of vandalism to site surveillance features. Because DOE does not have a responsibility to maintain the barbed-wire fence and gate, trespassing onto DOE property is difficult to control. DOE will continue to monitor for evidence of vandalism at the site.
